## Monitoring of the erosion process of the gully type in the Cesamar Park in the Municipality of Palmas - TO

Monitoramento do processo erosivo do tipo Voçoroca no Parque Cesamar no Município de Palmas - TO

Ana Karla C. Aragão de Faria<sup>I</sup>, Joel Carlos Zukowski Junior<sup>II</sup>, Flavio Augustus da Mota Pacheco<sup>III</sup>

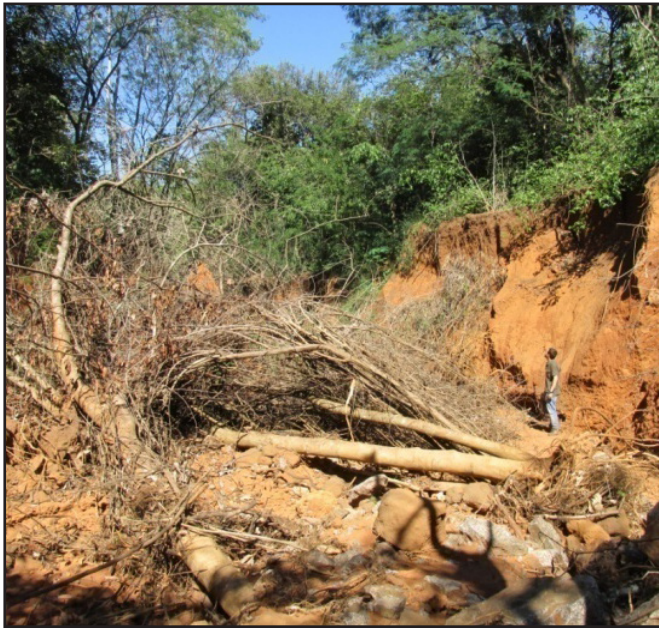
Figure 2 – Suppression of native vegetation

As the gully evolves, it is observed the suppression

of the native vegetation, which was caused by the action of the rainwater, which when flowing with great energy through the interior of the gully, carries the soil of the bases of the slope, causing the undermining the ground, and consequently the fall of the vegetation.

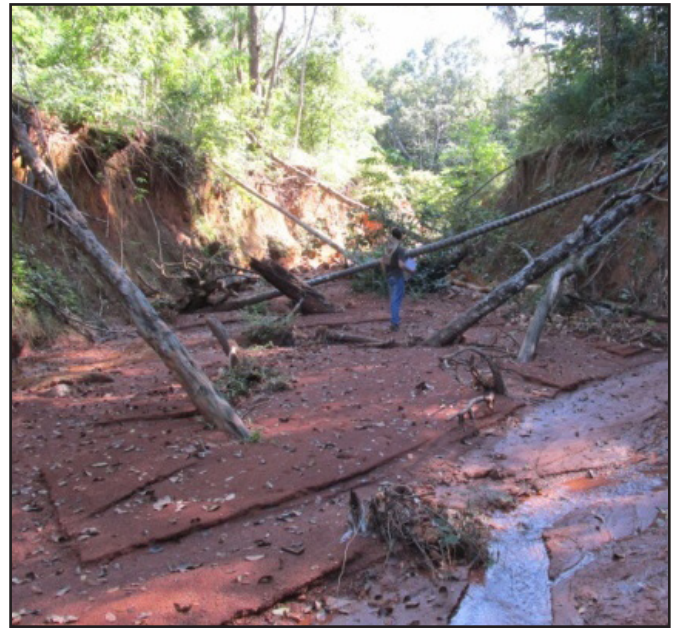
Figure 3 – Gully

In the first surveys, it was verified that the gully had a linear shape, as described by Augustin and Aranha (2006), presenting small branches and with a cross section being predominantly rectangular, in a "U" format, usually found in regions where soil and subsoil are easily erodible, as is the case of the sandy soil derived from the sandstones of the Pimenteiras Formation found in the area. The width varied from 4 (four) meters to 12 (twelve) meters approximately.

The erosion walls were almost vertical and had more

significant heights, ranging from two (2) to five (5) meters. The length was approximately 250 (two hundred and fifty) meters.

It was observed that in some points slopes with negative inclination were found, due to the fact that the course of the drainage is eroding intensely the shallower parts of the canal wall. Marginal vegetation was compromised due to increased erosion, and the various pedestrian and cyclist trails within the Park that are closest to the gully were compromised, with the risk of serious accidents.

Currently, erosion has a length of approximately 320 (three hundred and twenty) meters, an average width of 10 (ten) meters (reaching 16 meters in some points) and a maximum depth of 7 (seven) meters, in some points reaching the water level, thus characterizing the erosive process of the gully type.

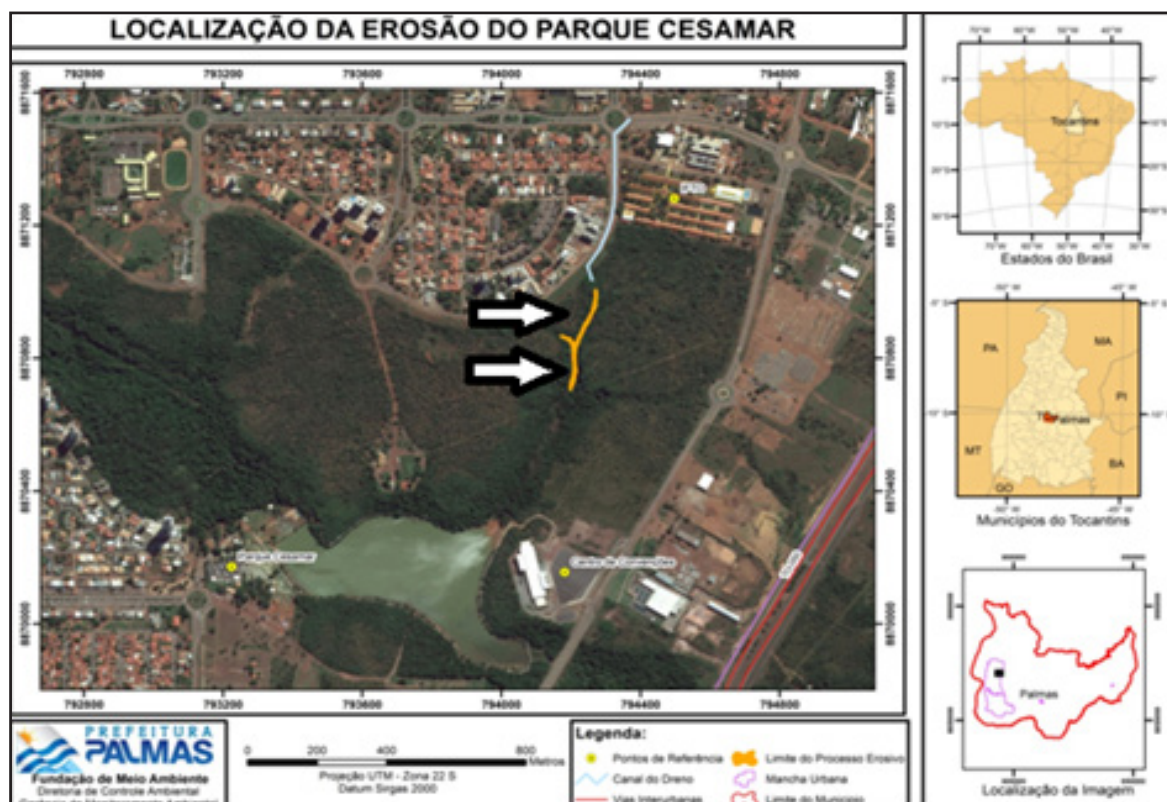
Figure 4 – Localization the erosiv process from the court AVSE 33

It is worth mentioning that the erosion length increased considerably during the rainy season, advancing upstream near the point of launching the drainage (approximately 30 meters) and the LO 07 Avenue (approximately 80 meters). The exact location of the area can be seen in Figure 04.
