Diagnosis and proposal of erosion control downstream of the Park Alfredo Werner Nyffeler, in Maringá – Paraná

Keywords: Urban erosion; Clayey soil; Gabion wall

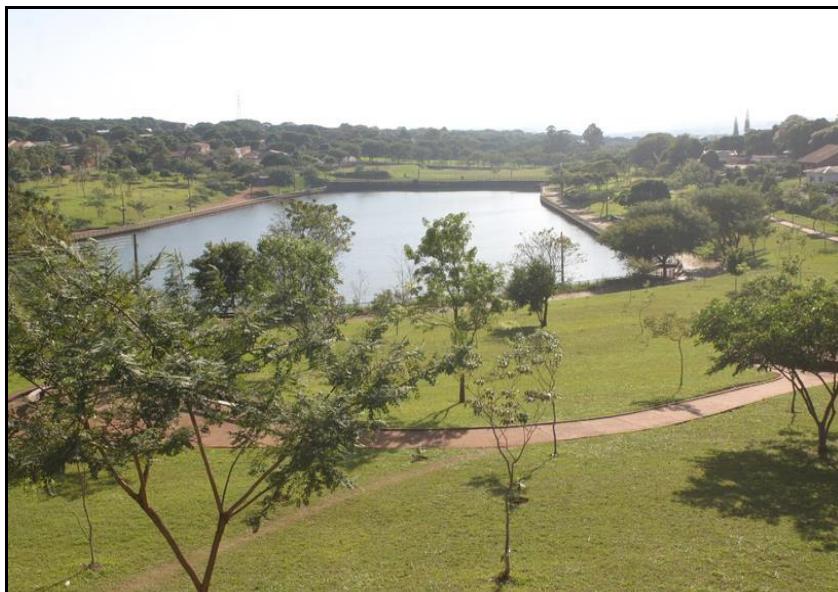
Figure 2 – Detention basin located in the park Alfredo Werner Nyffeler, in Maringá - PR

With the purpose of mitigating the problem, a detention basin was constructed to store surface runoff and stormwater, which arrives in a large amount and velocity in the terrain lowest point. This detention basin permanently holds a pool of water, used as recreation by the locals. Therefore, the park Alfredo Wener Nyffeler arose. However, some of the issues were transferred downstream to the park, area which the present paper will stick to. Figure 01 and 02 show the park location and the detention basin located inside the park Alfredo Wener Nyffeler, respectively.

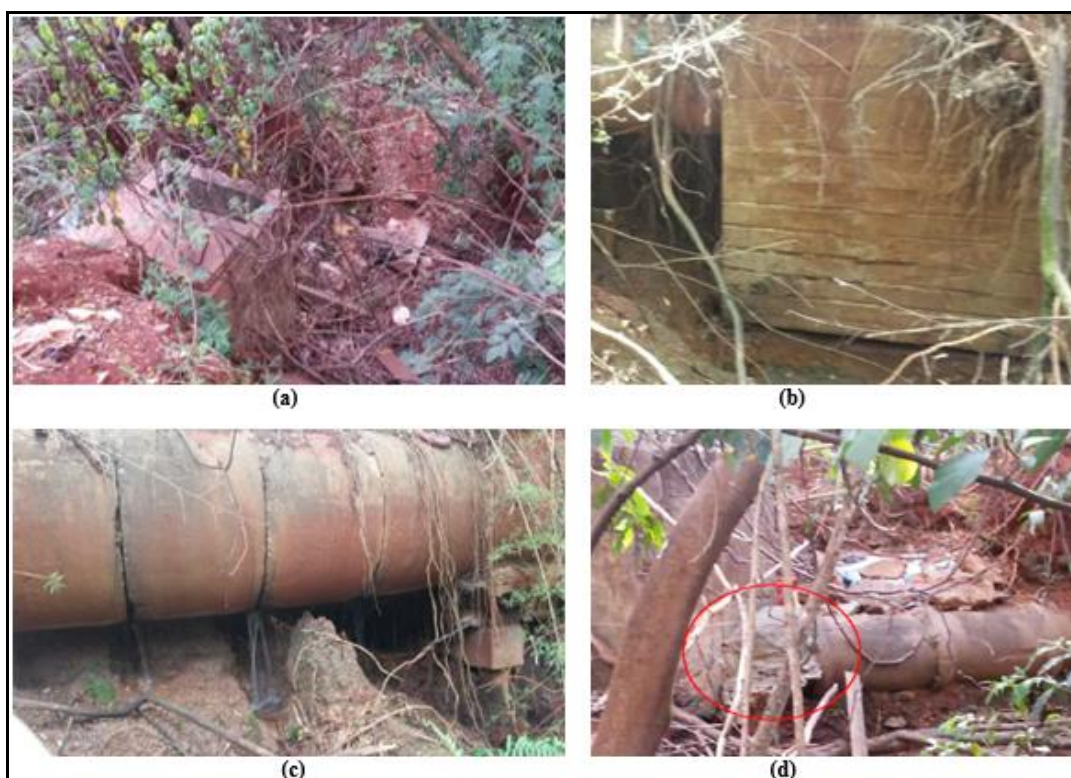
The urban drainage pipes installed with the purpose of transport the runoff flow from the detention reservoir during the flood season became insufficient for the flow peaks. Therefore, the existing junction box broke (Figure 3.a, Figure 3.b) together with the pipes. Leakages (Figure 3.c) and patches with mortar (Figure 3.d) are present as temporary solutions.

Figure 3 – Current state of the drainage system downstream of the park Alfredo Werner Nyffler

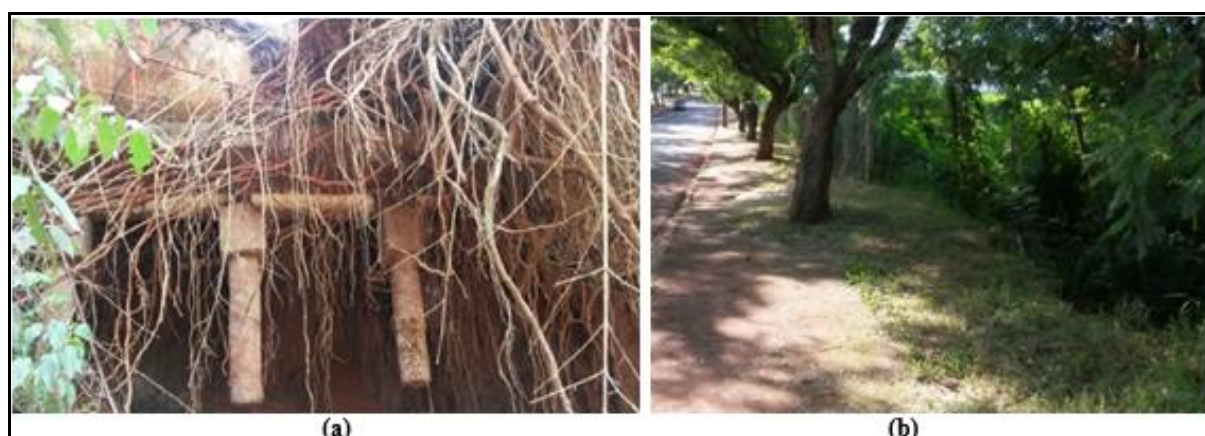
As result of all these mentioned incidences, the erosive process in the area was accelerated. The erosion compromised part of the drainage system, putting it in danger of collapse (Figure 4.a). Furthermore, the erosion is increasingly closer to the sidewalk, putting at risk the safety of people, especially children, passing through the area (Figure 4.b).

Figure 4 – Erosive process downstream the park Alfredo Werner Nyffler

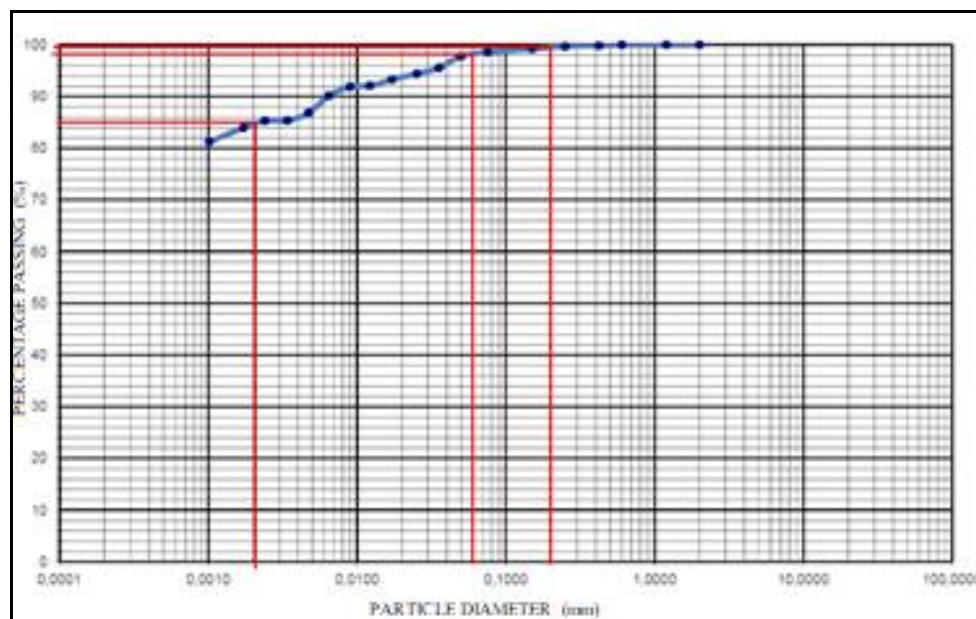
Gradation tests showed that there is a fraction of 85% of clay (particles with dimension smaller than 0,002mm), 13% of silt (particles with dimension between 0,002 mm and 0,06 mm), 1% of fine sand (between 0,06 mm and 0,2 mm) and 1% of medium sand (between 0,2 mm and 0,6 mm). Thus, the analyzed soil is classified as silty clay (Figure 5).

Figure 5 - Grain size distribution graph, with cumulative percent passing (%) x grain diameters (mm)

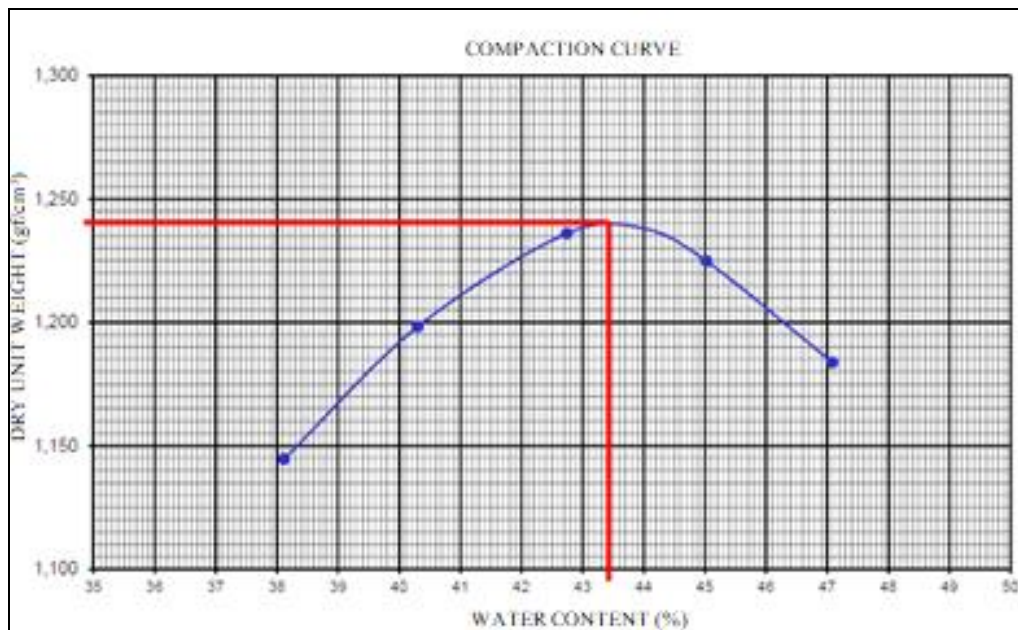
In order to execute the embankment and identify the optimal compaction conditions, the compaction curve in normal energy was plotted, following the Brazilian standard NBR 7182 (ABNT, 1988) (Figure 6). The optimum water content found was 43,4% and the maximum dry unit weight, 12,42 KN/m³ (Table 1).

Figure 6 – Compaction curve

Based on the compaction test results, it was observed that the optimum moisture content was 43,4% and maximum dry unit weight, 12,10 KN/m³. These parameters must be taken into account when executing the embankment in the study area since it aims for a higher erosion resistance.

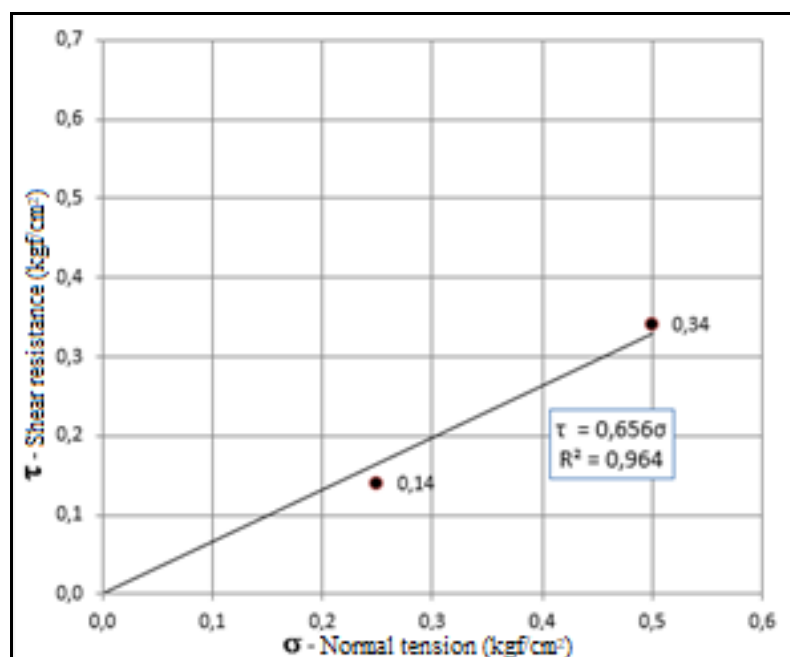
Figure 7 – Coulomb resistance envelope for the soil in natural conditions

$$\tau = 0 + \sigma_n 0,656$$

$$c = 0 \text{ (cohesion)}$$

$$\varphi = 33,26^\circ \text{ (friction angle)}$$

According to the results, it was observed that the soil cohesion is zero, meaning that the clayey soil has a non-cohesive behavior.

The shear resistance was determined through the shear resistance test. Three rupture values for each state were used to plot the circles of stress for the soil in natural conditions (Figure 7), with optimal moisture content in the maximum unit weight in the normal compaction effort (Figure 8) obtained from the compaction curve and 90% of the maximum unit weight (Figure 9). The graphs show the Mohr-Coulomb resistance limit, in which any point above these values, for each given soil and state, represents soil rupture. The cohesion and friction angles were determined by the Mohr-Coulomb failure criterion equation.

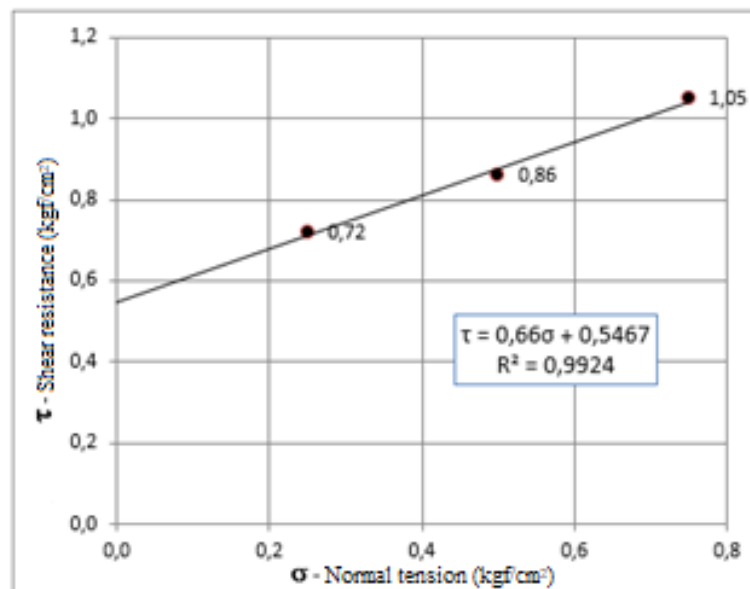
Figure 8 – Coulomb resistance envelope for the soil in conditions of maximum unit weight and optimum water content

$$\tau = 0,5467 + \sigma_n 0,66$$

$$c = 0,5467 \text{ (cohesion)}$$

$$\varphi = 33,42^\circ \text{ (friction angle)}$$

The shear resistance test in the optimal compaction conditions, that is, optimum water content and maximum dry unit weight, and optimal water content and 90% of the dry unit weight are performed using undisturbed soil samples. Analyzing the results, one can notice that this soil, after compaction and in non-drained conditions, still presents cohesion, which means that there was an increase in the soil shear resistance after compaction.

In the optimal compaction conditions, the value found for cohesion was 0,5467 and for friction angle, 33.42°. In the optimal water content and 90% of the dry unit weight, the cohesion was 0,13 and friction angle, 40,03%. After obtaining these laboratory results, it was possible to choose the better contention method.

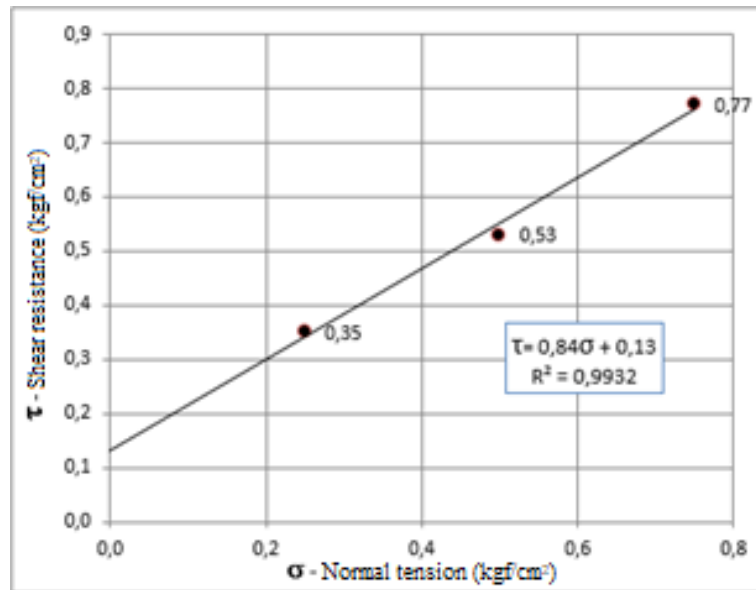
Figure 9 – Coulomb resistance envelope for the soil with 90% of maximum dry unit weight and optimum water content

$$\tau = 0,13 + \sigma_n 0,84$$

$$c = 0,13 \text{ (cohesion)}$$

$$\varphi = 40,03^\circ \text{ (friction angle)}$$

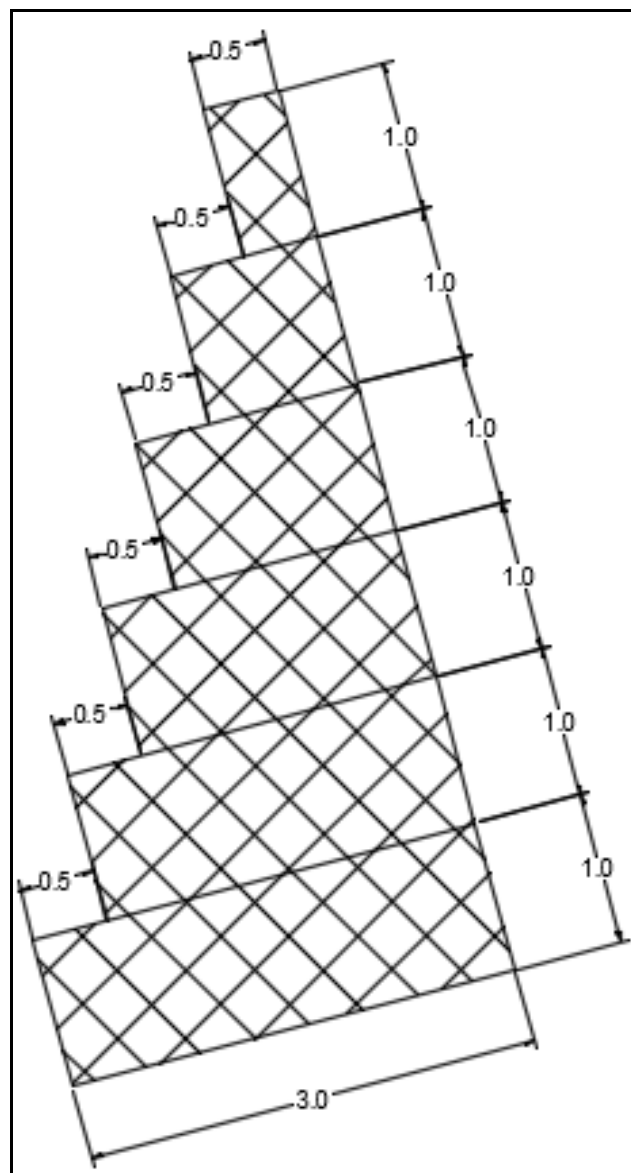
Thus, the embankment starts in the lowest point of the terrain, at the base of the retaining wall, not considering the embedment of 0,85m. The geometry of the wall section and soil massif is shown in Figure 10.

The terrain unevenness is 5,144m, which corresponds to the necessary wall height. However, as an initial attempt, the wall embedment depth was considered approximately 0,85m, which was tested in the Gawacwin and a report was generated. The total wall height will be, therefore, 6,0 meters.

An overload of 1 KN/m² was adopted in order to represent the terrain vegetation. In addition, a slope of 10° for the wall was considered, so its own weight contributes to the structural stability against slide and toppling.

The gabion is composed of a net of 8 x 10 @ 2,7 mm CD, filled by rocks with a unit weight of 24,20 KN/m² and porosity of 30%.

The embankment soil has a unit weight of 11,16 KN/m², angle of internal friction 40,03° and cohesion $c = 13,00$ KN/m². The natural soil, which also composes the structure foundation, has a unit weight of 11,80 KN/m², friction angle of 33,26° and cohesion $c = 0$.

Figure 10 – Scheme of the gabion wall

With this data as input for the software, the results were analyzed according to the safety coefficients. Remembering that, according to the Brazilian standards, the minimum safety factor in this situation is 1,5. The values found by the software for the stability factors were: safety factor for sliding = 2,76; safety factor for toppling = 2,11; global failure safety factor = 1,52. All the safety factors are lower than 1,50. Thus, the retaining structure resists against the tension exerted by the soil with efficiency and stability.

The safety factor for global failure is quite close to 1,50, which means that the wall dimensions cannot be decreased and the structure sizing is optimized.

Therefore, the gabions wall is proposed as one of the erosion retaining measures, as the scheme shown in Figure 10.
