## Monitoring of the erosion process of the gully type in the Cesamar Park in the Municipality of Palmas - TO

Monitoramento do processo erosivo do tipo Voçoroca no Parque Cesamar no Município de Palmas - TO

Ana Karla C. Aragão de Faria<sup>I</sup>, Joel Carlos Zukowski Junior<sup>II</sup>, Flavio Augustus da Mota Pacheco<sup>III</sup>

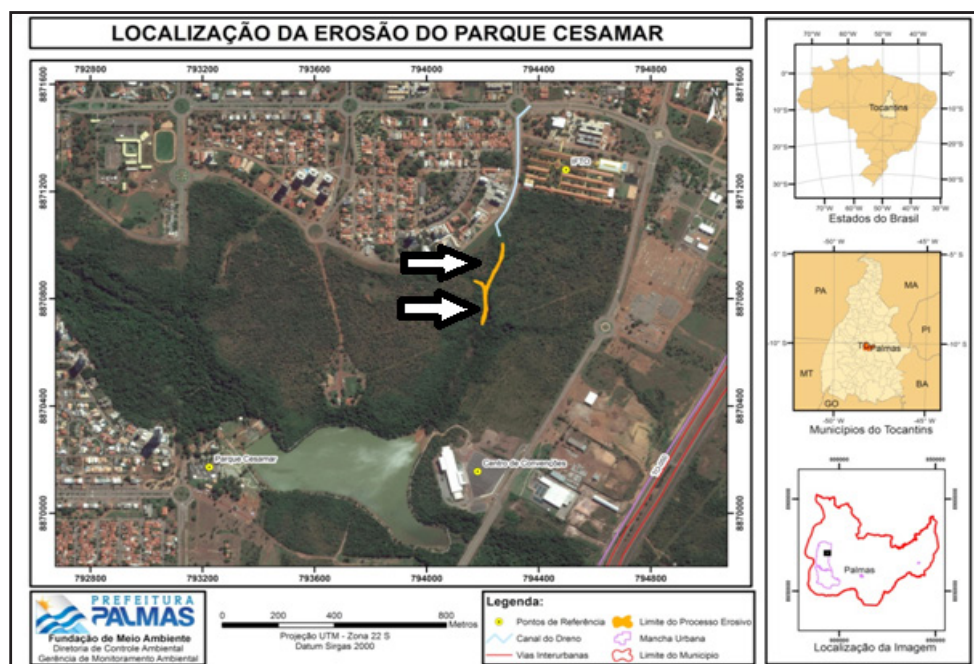
Figure 1 – Location of the erosive process of the AVSE block 33

The analysis started from the location of the gully, which is approximately 500 (five hundred) meters from the Metropolitan Guard of Palmas building, inside the Cesamar Park, from the end of the gully, that is, from the point downstream of the headwaters. Figure 1 shows the georeferenced location of the erosive process at the beginning of the surveys.
